Wildfire on the Woodfibre LNG Property: July 20th 2021 – 90d Report

Re: Wildfire Response Assessment and Recommendations

Squamish, BC Project No. 16276

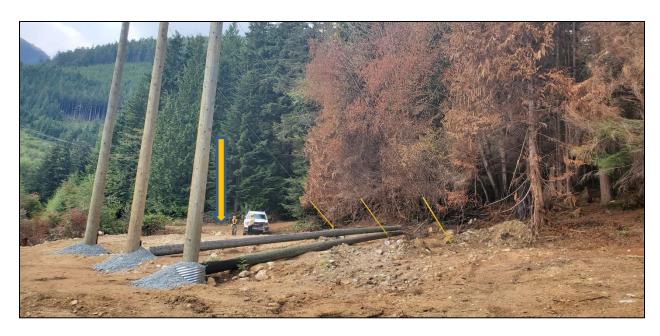
The infilled watercourse has been confirmed as an ephemeral tributary of watercourse M3, a non-fish-bearing tributary of Mill Creek. An approximate 8 m section of channel was infilled to provide access to fire response crews to extinguish the wildfire immediately east of the creek. The fire fighting efforts included significant earthworks, vegetation removal, and soil disturbance (see attached **Photograph 2**) in the vicinity of the tributary up to the immediate channel banks.

Photograph 1: View of small section of watercourse that was infilled as part of wildfire response (indicated by orange arrow).

1. Following applicable legislation, and subject to review by a Qualified Environmental Professional (QEP), an approximate 8 m section of a non-fish bearing, ephemeral tributary of Mill Creek which was infilled will require restoration to prevent erosion and sediment mobilization to downstream areas and downstream impacts. It is understood that the prior location was used as an "open ford crossing," and that re-establishment of a ford crossing is desired. A design which includes armoured approach aprons at the banks and armoured

channel invert is recommended. Angular rock of 3" to 8" size class or similar may be utilized so long as it is clean and free of sediment or as determined by a QEP.

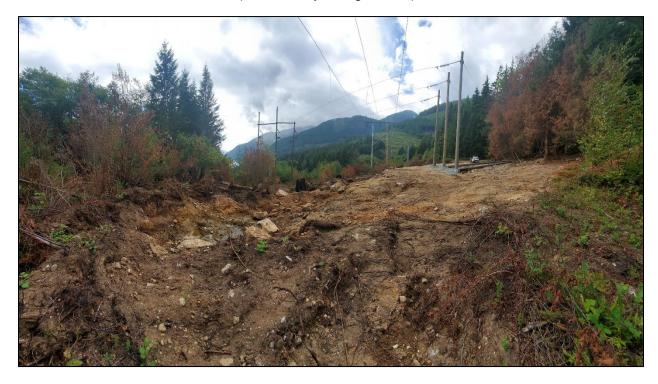
Photograph 2: View of disturbed area due to wildfire response within BC Hydro Right-of-Way.

- 2. Re-grade/finish grade disturbed soils to re-establish the pre-disturbance ground profile. Leave soils "rough and loose" to promote seed germination and infiltration. Spread native topsoil, organic matter, and logs over mineral soils (where present) to promote infiltration and seed germination

- 3. Install erosion prevention and sediment control measures such as 8" straw wattles along the stream banks to prevent sediment transport to the tributary and downslope watercourses. Wattles must be staked in place as per the manufacturer's specifications. Additional wattles should be laid along the lower slope contour and at the mid slope contour within the disturbed area.

- 4. Stabilize soils with a "coastal reclamation grass seed mix" or equivalent at a rate of 56-112 kg per hectare. A late fall seed mix coupled with application of straw mulch applied at a rate of one bale per 75 m² is recommended. Alternatively, the area can be hydroseeded with a bonded fibre matrix (BFM) hydroseed utilizing a "fall mix" reclamation grass seed.
